## **Assessment of conservation status of wetlands in the Trayning area in relation to disposal of saline deep drainage water**

**Prepared for  
Avon Catchment Council  
by Bennelongia Pty Ltd**

**September 2007**

**Report 2007/10**

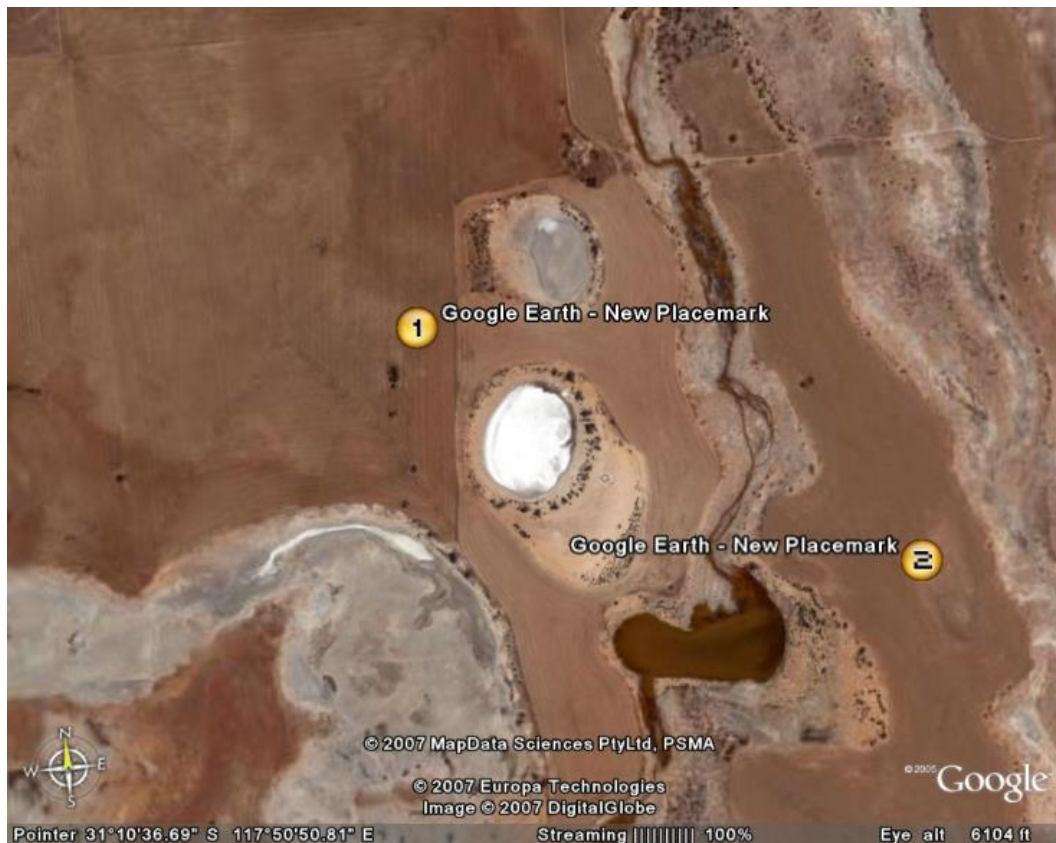
A small saline, acidic lake with no visible connection to the main drainage channel (Figure 3.1.1). The wetland is characterized by a very high level of anthropogenic influence that has severely degraded the biological values of the wetland and riparian vegetation. Overstorey and understorey shrub species of riparian zone have been almost eliminated, as has the original salmon gum woodland around the perimeter of the lake (Figure 3.1.2). Grazing by stock and rabbits has substantially suppressed recruitment of native and introduced plants.

On the eastern side of the wetland there is a low sand dune, sparsely vegetated with an open acacia shrubland that has been trapping recently windblown sand. Closer to the wetland on the eastern side, the soil is severely wind eroded and is devoid of live vegetation. Numerous stags of relic shrubs and trees are visible in this erosion zone.

Figure 3.1.1. Lake #1, showing proximity to river system, and Lake #2 to the south east. The area of acacia where sand is being trapped is visible to the south-east of the wetland, with eroded bare sand between it and the sparse riparian vegetation

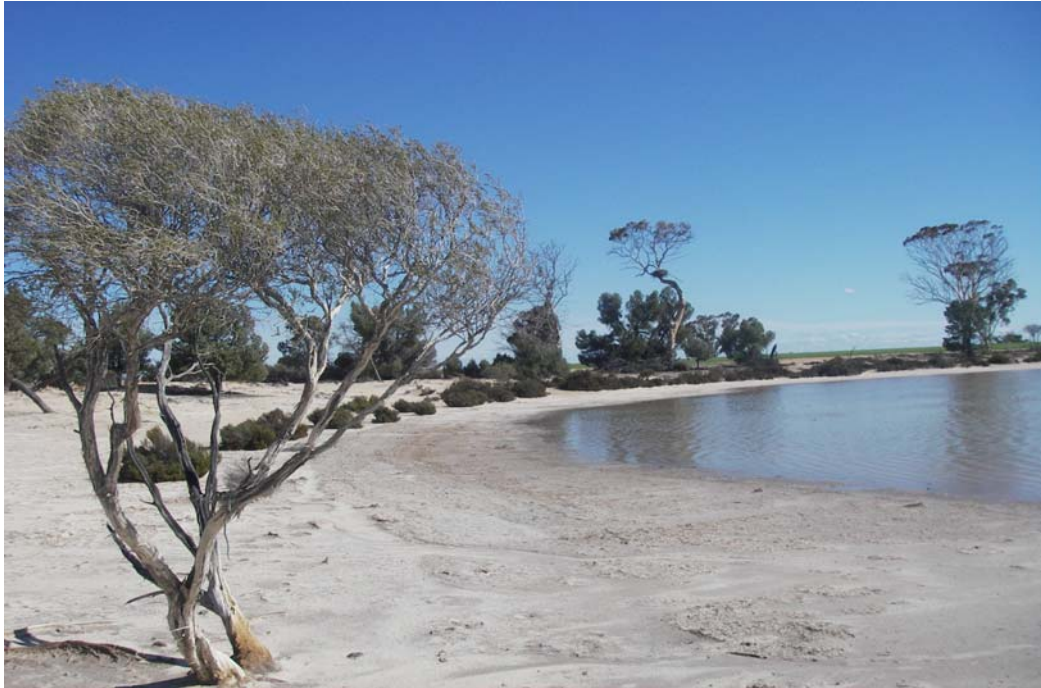
Figure 3.1.2. Wetland #1, looking south-west towards cropland. Remnant salmon gum woodland over callitris understory is highly degraded. Riparian wetland vegetation is highly degraded, with erosion of the wetland bank and accumulated sediment on the lake-bed visible

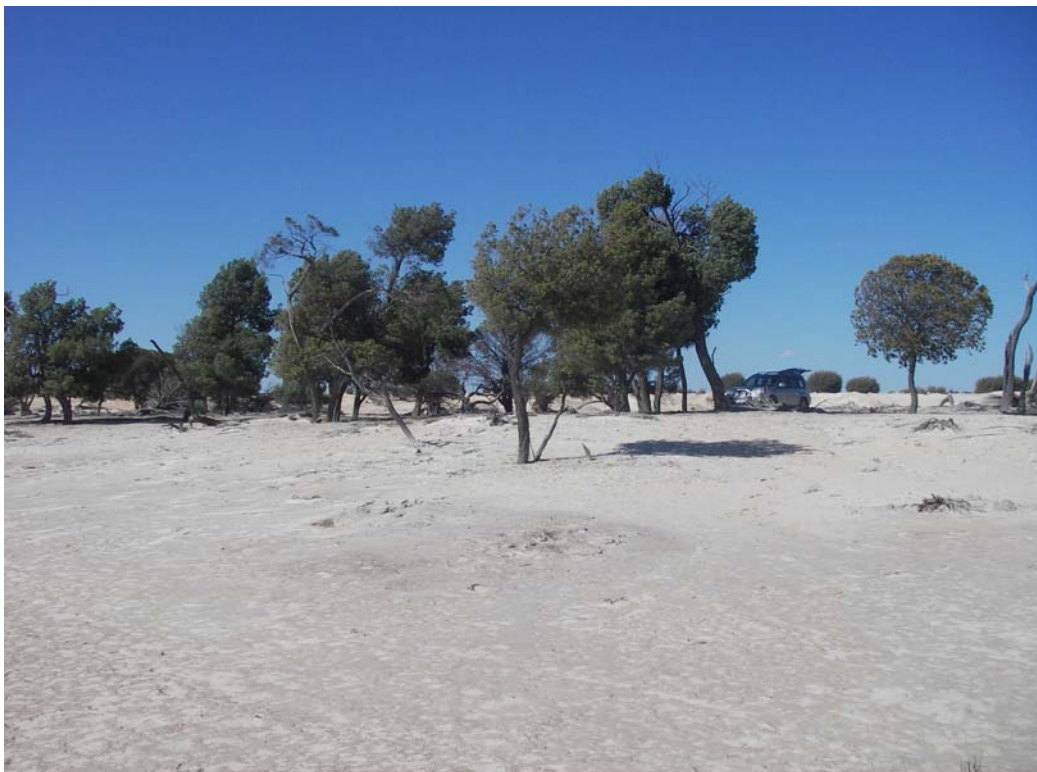
Figure 3.1.3. Looking east from wetland #1 at the low sand dune between it and the drainage channel. In the mid-ground is a sparse *Callitris canescens* woodland and one remnant *Santalum acuminatum* (Quandong). Wind erosion and grazing (sheep and rabbits) has prevented plant recruitment

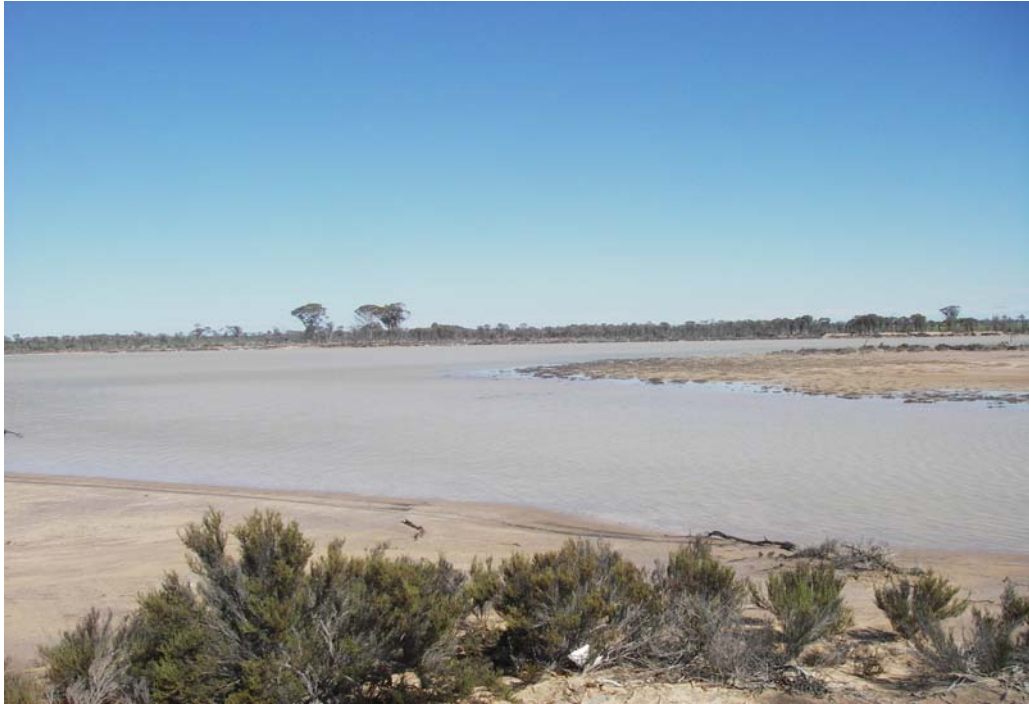
A small saline, acid in-line wetland showing high levels of impact from salinisation and the influence of inundation by floodwater (Figure 3.1.2). Overstorey and understorey shrub species of riparian zone have contracted substantially in distribution but still remain at higher elevations. There is evidence of considerable death of vegetation within the last year (some within the last few months), apparently as a result of inundation (Figures 3.2.1 and 2). Water levels had been substantially higher prior to field inspections. Currently, the wetland is characterized by a fringe of dead samphire and small patches of deteriorating melaleuca shrubland on slightly higher ground. Cropland occurs within a short distance of most of the wetland. A small eroded dune to the east supports the remnant of an acacia shrubland.

Figure 3.2.1. Wetland #2, salt/acid damaged samphire plants in the foreground and samphire plants that had succumbed to inundation in the middle distance

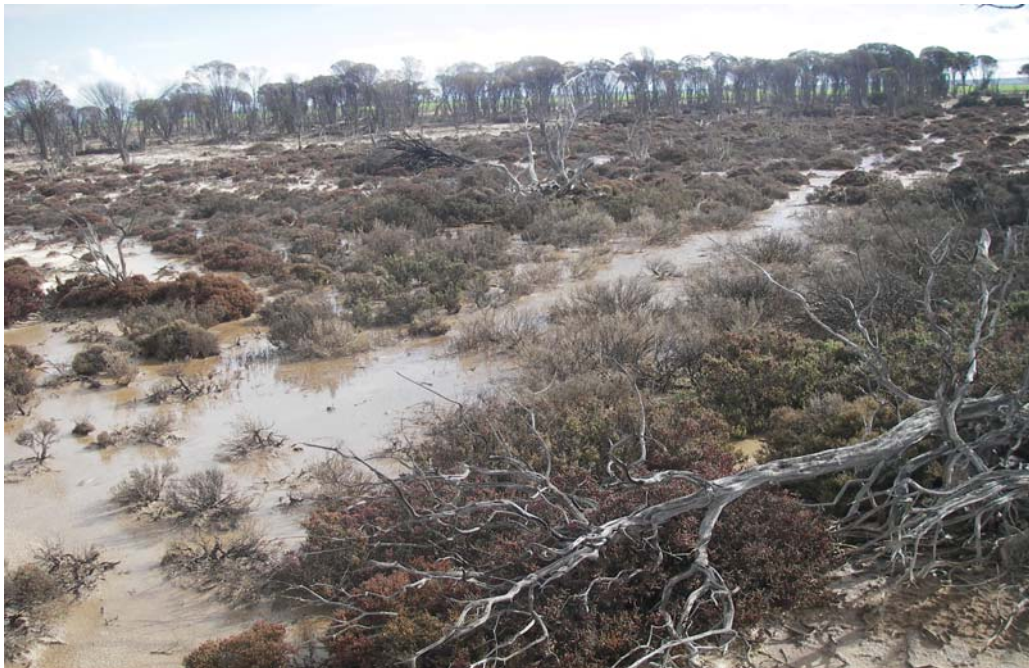
Figure 3.2.2. Wetland #2 where flooding had killed much of the low samphire marsh, especially along drainage lines. Compacted pathways created by sheep provided an additional impediment to recruitment of native plants. The melaleuca shrubland in the background was thinned and severely affected by inundation with saline/acidic water

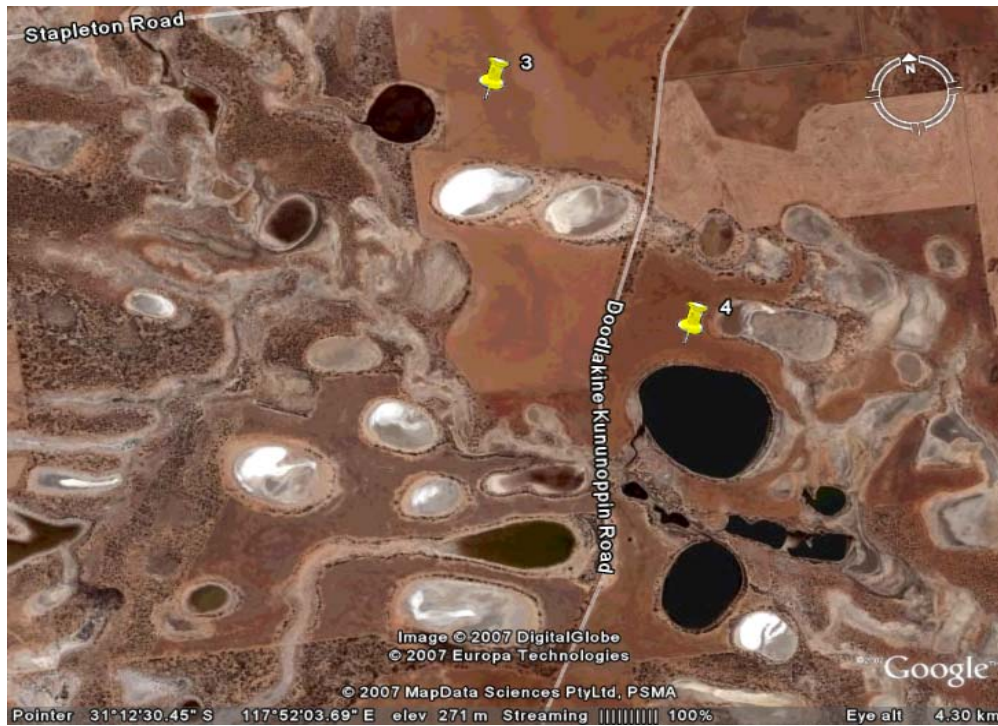
A small circular saline, slightly acidic wetland that lies about 700 metres east of the main river system, off a less incised channel. The lake has a single drainage connection to the river system on the west side that allows entry of river water during flood events and exit when the lake is full. Cropland occurs very close to the eastern boundary of the lake and sheep grazing has impacted severely on the recruitment and survival of native vegetation around the entire lake. Overstorey and understorey shrub species of the riparian zone have contracted substantially in distribution but there are occasional remnants at higher elevations. To the west, is a severely degraded salmon gum woodland occurs.

Figure 3.3.1. Wetland #3, showing connectivity to the drainage line and proximity of eastern half of wetland to farmland. Wetland 4, showing its connection on the western side to the drainage line and the extent of cropping around it

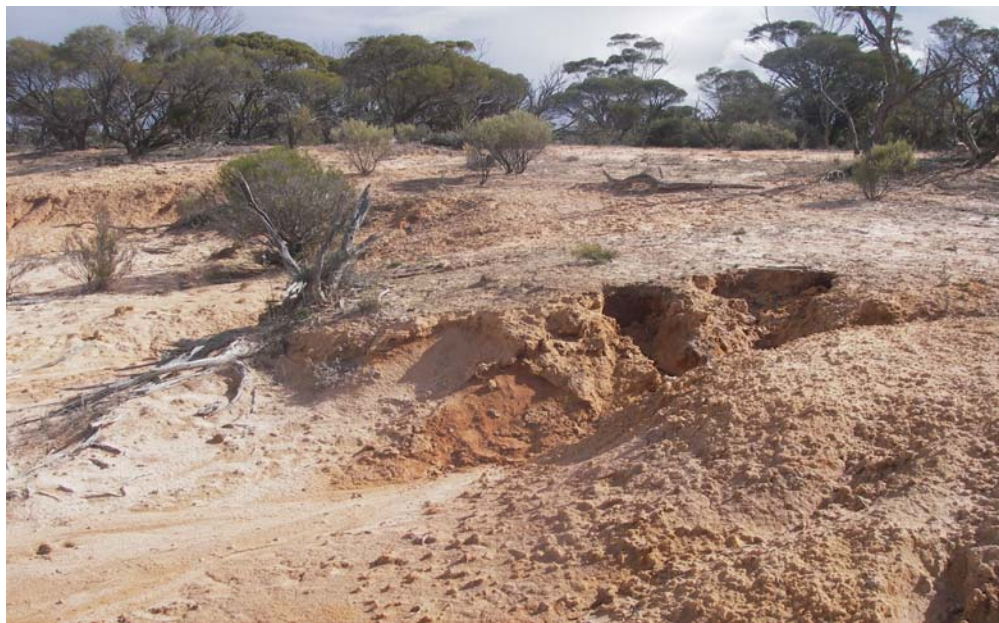
Wind and water erosion has undercut the wetland's banks and lead to substantial siltation of the lakebed. The film of water on the lakebed at the time of the survey was saline, but only slightly acidic (pH 5.6), unlike other wetlands which had strongly acidic water. The remnants of an old fence line through the lake are still present.

Figure 3.3.2. Wetland #3, showing siltation of the lake from wind and water erosion of the lake shore, which has been exacerbated by grazing

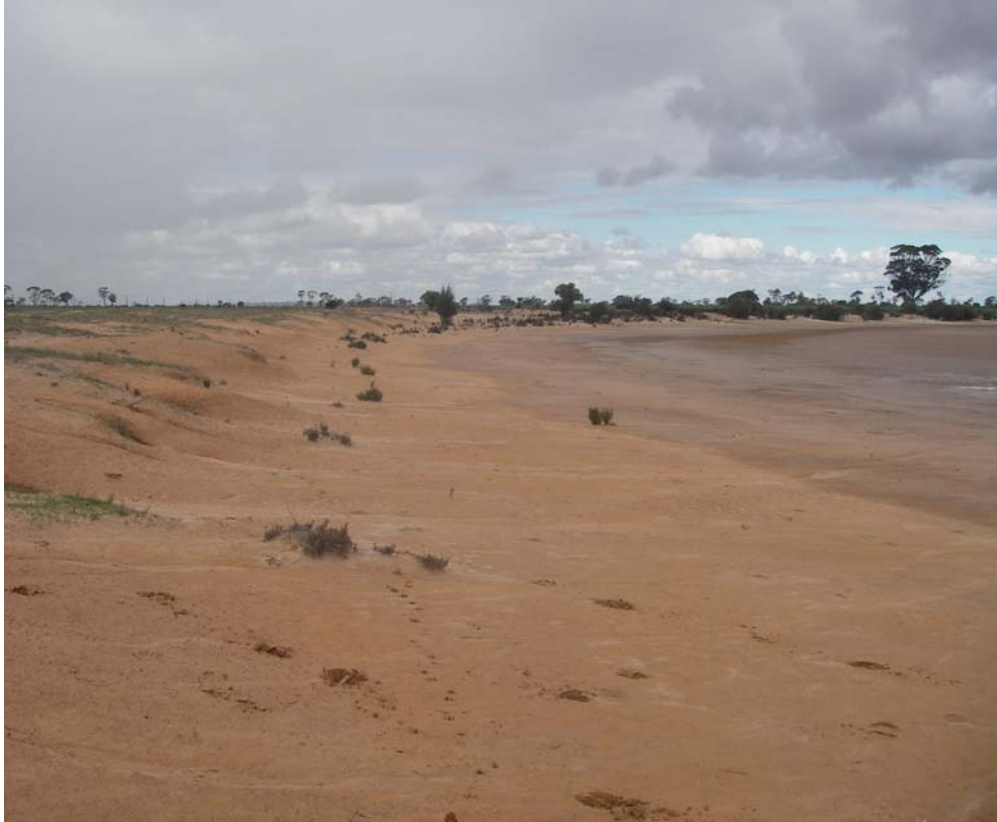
Figure 3.3.3. Wetland #3 where cropping to the edge of the wetland and grazing of stock has removed native vegetation

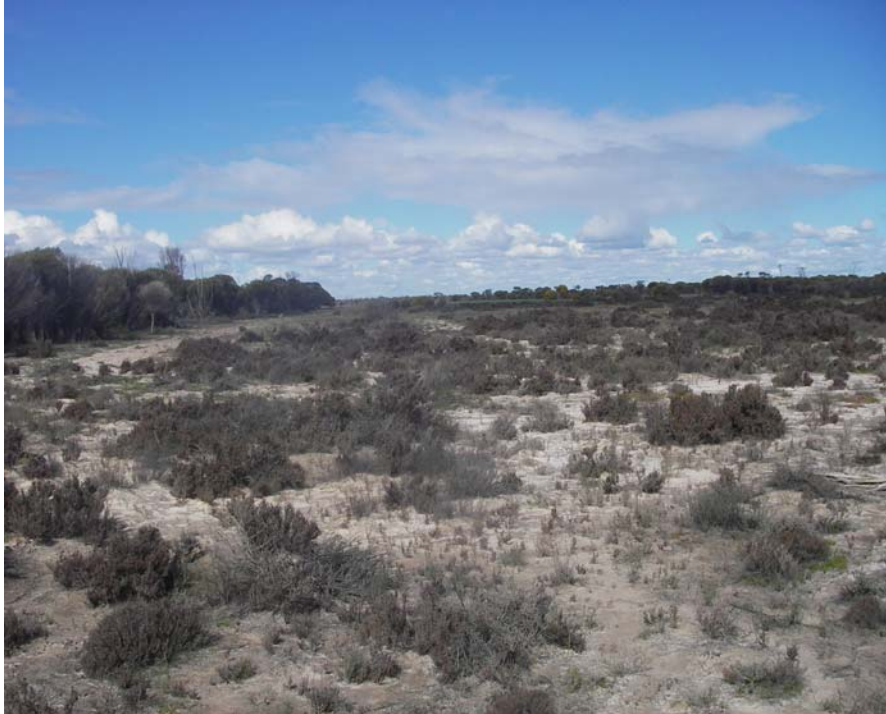
A medium-sized circular saline, acid wetland that is connected to the main river system by one channel on the south west corner. While water levels were extremely low at the time of the survey (0.02 m), flooding in the recent past has killed much of the salt marsh community along the drainage channel and around the edge of the wetland. The melaleuca woodland at higher elevation on the southern shore shows signs of stress that is probably the result of inundation of the root zone with saline acidic water.

Figure 3.4.1. Wetland #4, showing that flooding or rising groundwater has killed much of the samphire community in the swale behind the first dune on the south side of the lake. The melaleuca woodland on the low dune marking the usual shoreline (when flooded) is showing significant stress. Little recruitment of saltmarsh plants was observed

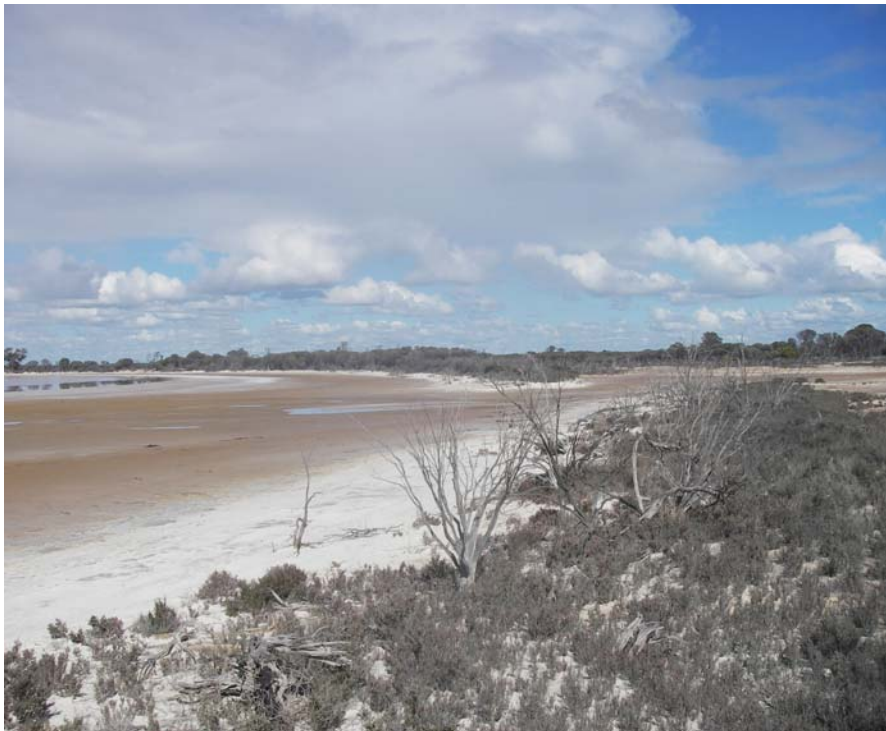
Figure 3.4.2. Looking south along the dune within the lake on the western side, illustrating the loss of overstorey riparian vegetation and the poor health of remnant saltmarsh communities

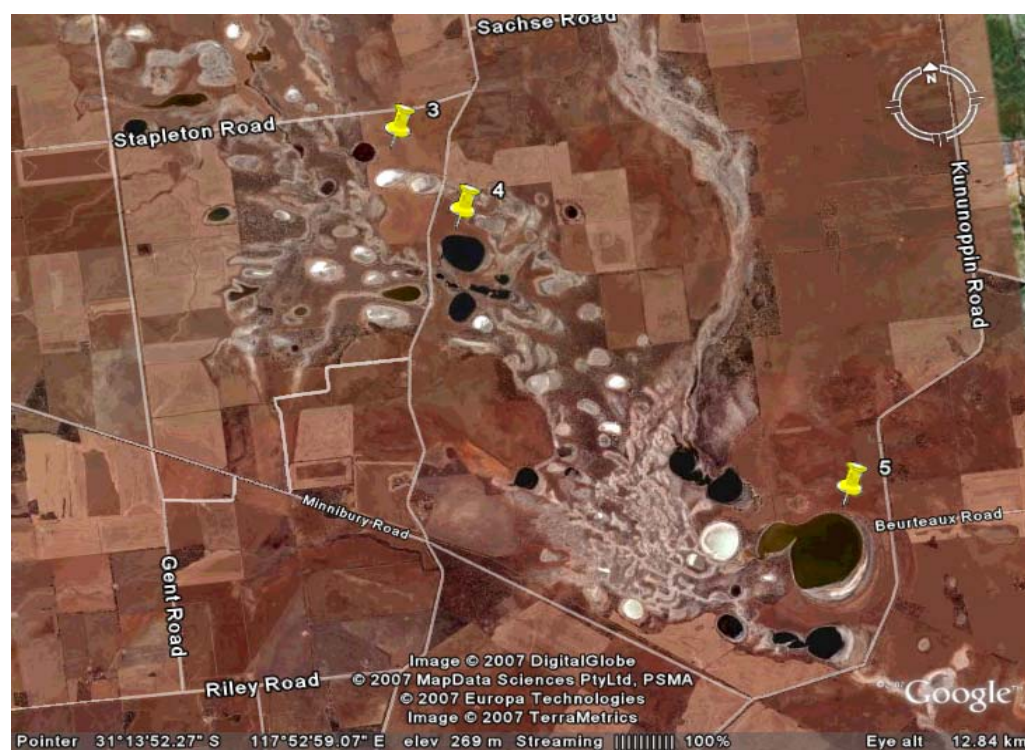
A medium to large saline, acidic wetland with a single direct connection to the main river system. The lake has a well developed dune system with three dunes with two swales between them. The last dune rises to upland that has been cleared. However, much of the beach vegetation and first dune is dead and vegetation on the lower parts of the other two dunes is also dead, with the remainder looking as though it is dying back (although some recruitment was occurring on the back edge of the middle dune). Much of the samphire in the swales is also dead or unhealthy, while a thick salt crust (2.5 cm) occurs on the lakebed, suggesting there is discharge of groundwater is occurring. As in most of the wetland system, pH is very low (3.5).

Figure 3.5.1. Wetland #5 connection to the main river system and proximity to wetland #4

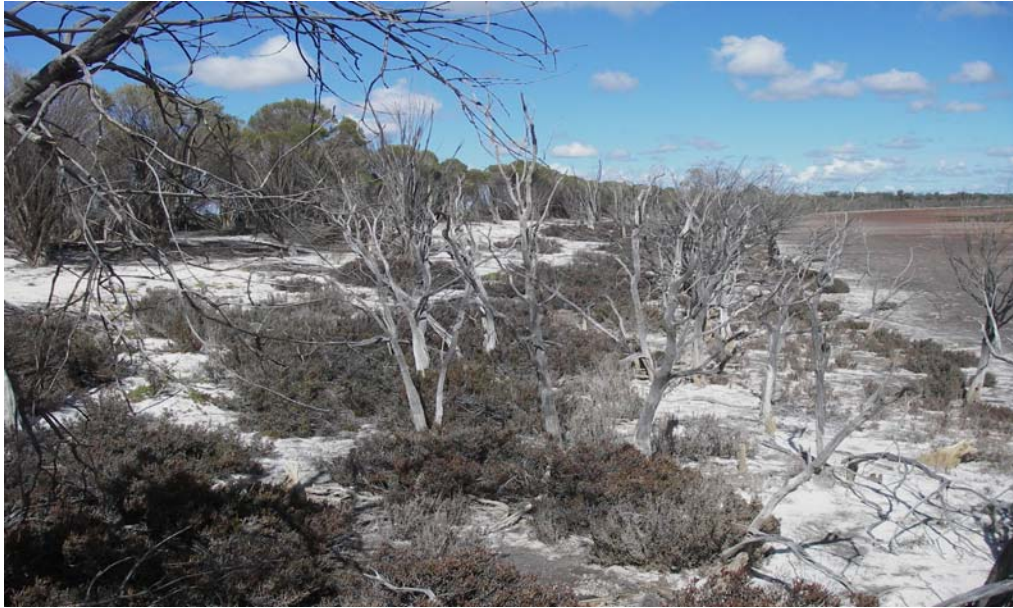
Figure 3.5.2. Wetland #5, showing the loss of the melaleuca community on the face of the first dune and beach

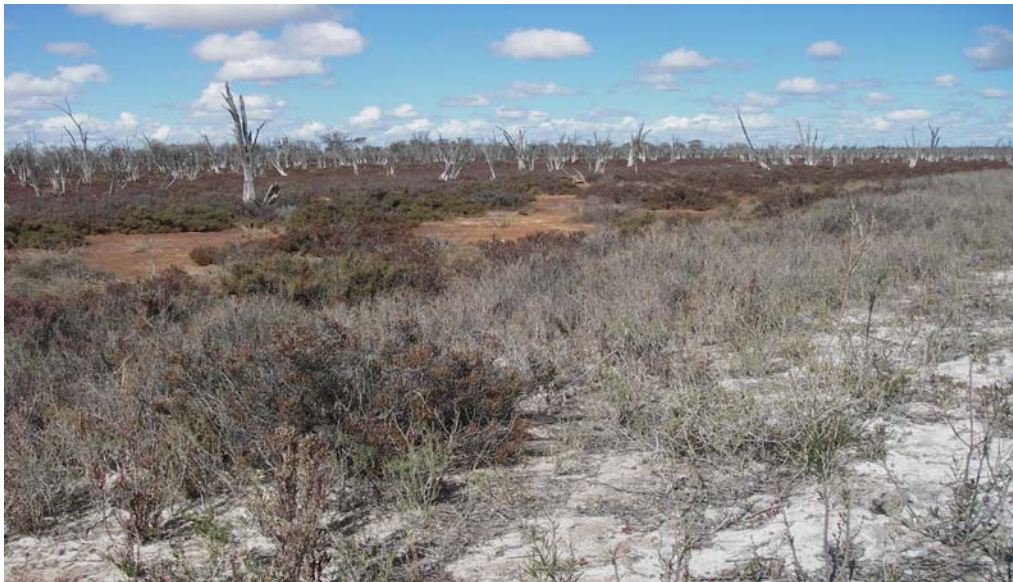
Figure 3.5.3. Wetland #5, showing the extent of plant death on the back of the second dune. The saltmarsh community in the swale are also sparse and unhealthy

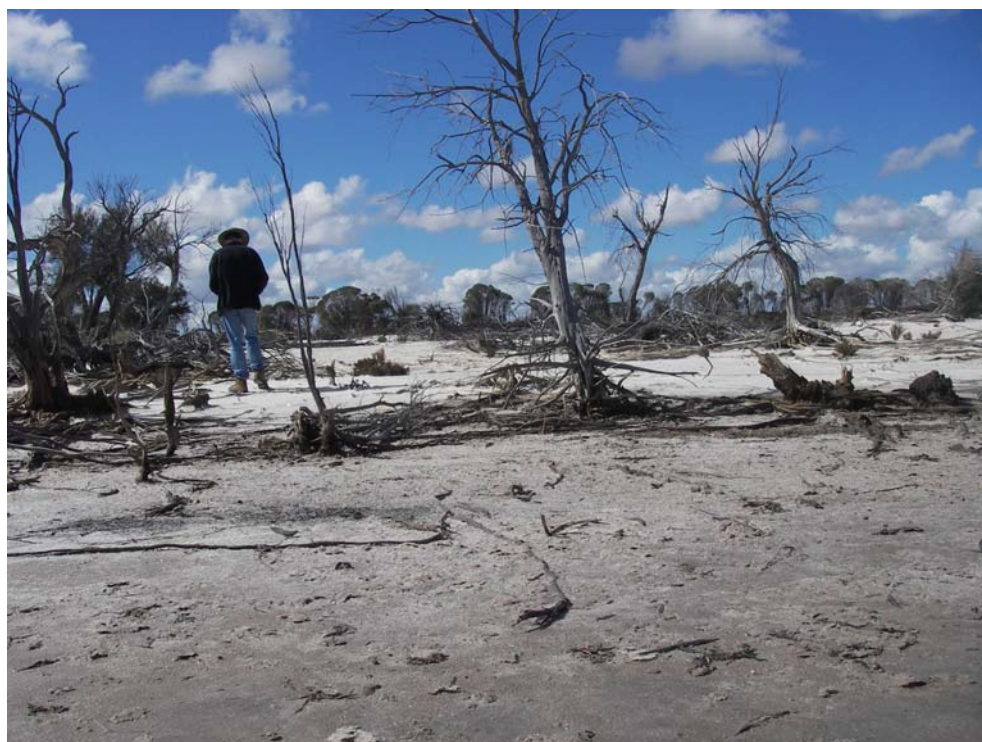
Figure 3.5.4. There is the severe erosion around the beach and first dune of wetland #5, as shown by the exposed roots of dead casuarinas. In some areas there is very little vegetation.

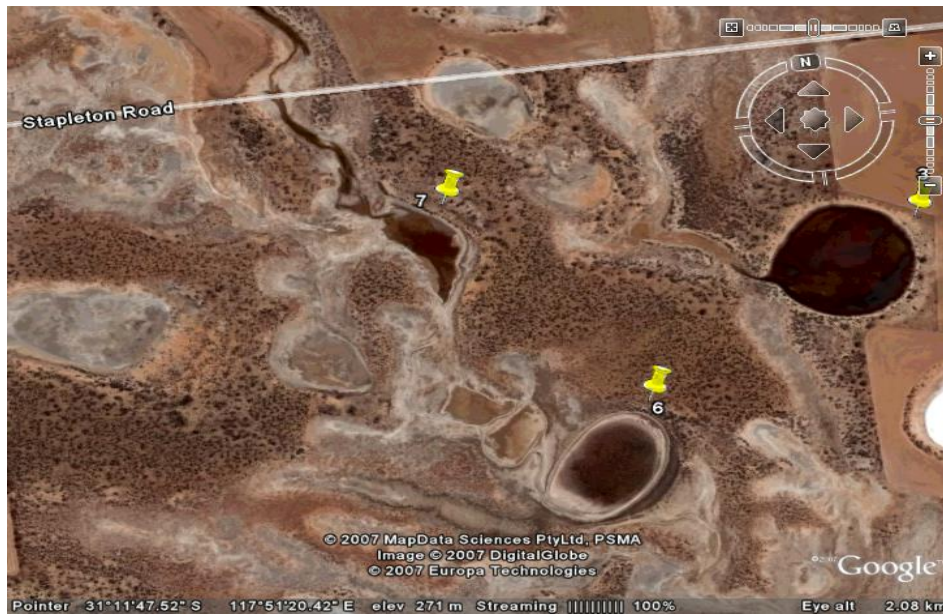
A small acidic, saline lake that receives water from the main river system. Riparian overstorey and understorey shrub species have contracted substantially in distribution but still remain around the wetland margins at higher elevations. Much of this vegetation is, however, highly impacted by prolonged inundation within the last 5 years or so and on the north side the shrubland of melaleucas remains only as dead stags, while the area of samphire has contracted. Recruitment of succulents and introduced weed species is occurring in higher parts of the dune around the wetland.

Figure 3.6.1. The location of wetland # 6 in relation to the main drainage and wetlands #3 and 7. Note wetland #6 is usually a terminal basin and overflows only during periods of significant flooding

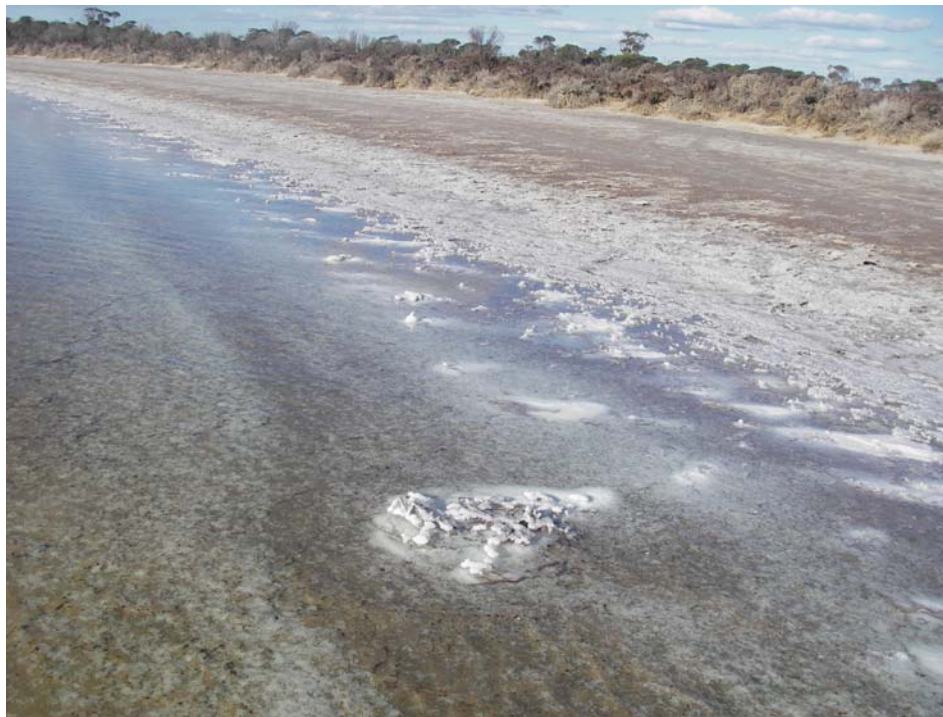
Salt accretion was evident along the foreshore and a thick salt crust occurred on the lake bed, suggesting the discharge of groundwater is occurring at wetland #6. A channel on the southern side suggests that water levels have been sufficiently high to breach the southern dune and drain out of the lake to the south.

Figure 3.6.2. Wetland 36, illustrating the heavy salt deposits and impact on the riparian vegetation of flooding with acidic saline flood water

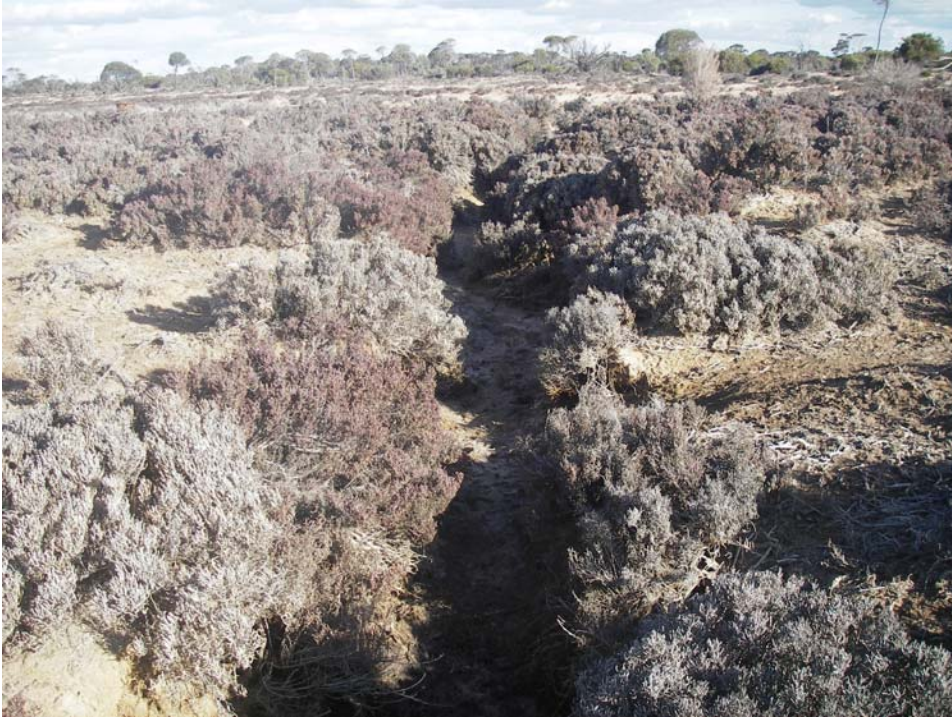
Figure 3.6.3. A deep channel has been cut out of wetland #6 by floodwaters. The channel leads to a narrow drainage line to the south. Riparian vegetation in this area is heavily salt-affected. No recruitment is evident

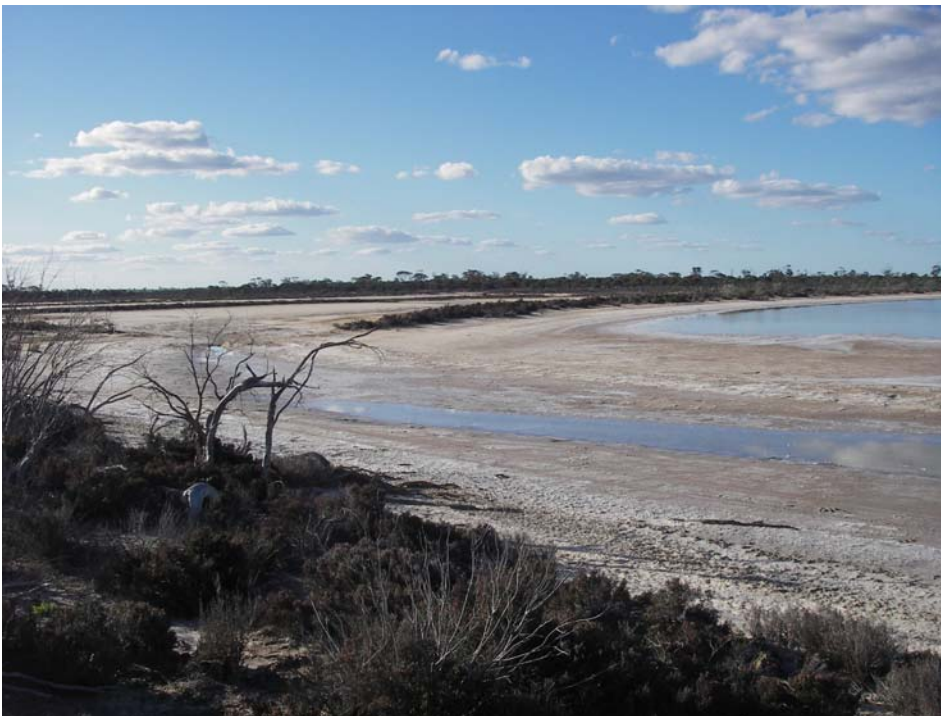
Figure 3.6.4. The entrance of the river into wetland #6. In the foreground are dead stags of melaleuca and samphire, with recruitment of succulents on the higher parts of the dune. In the background is the contracting riparian zone of samphire, low melaleuca and acacia that leads to a salmon gum woodland on the uplands

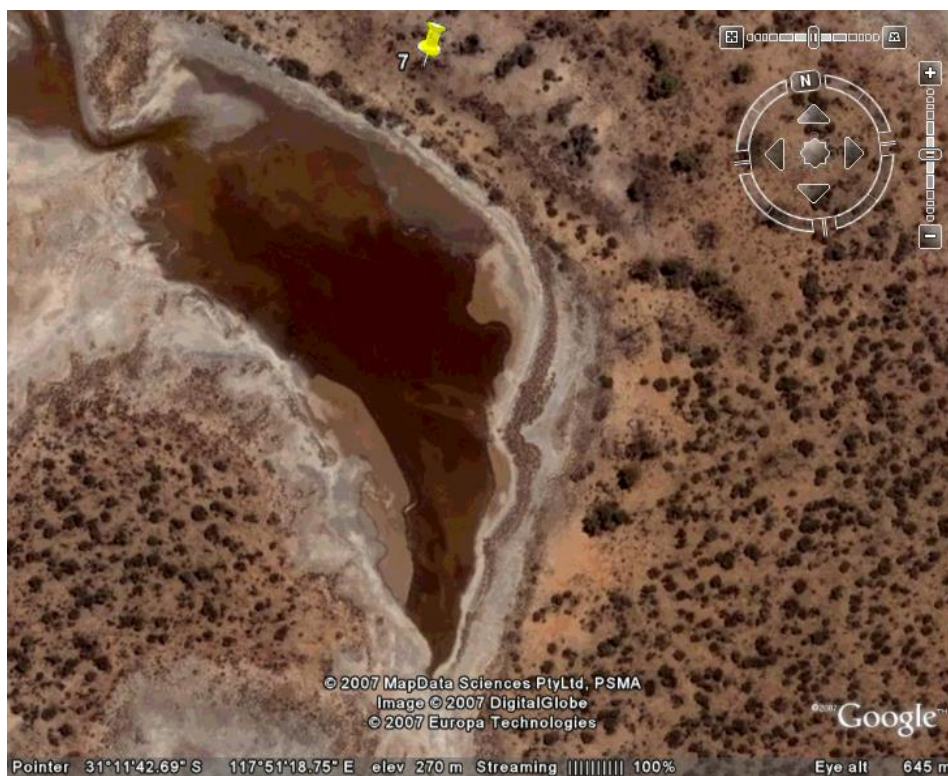
A small acidic, saline river pool that is connected to wetland #6. Overstorey and shrub species of riparian zone have contracted substantially in distribution but still remain around the wetland margins at higher elevations. Much of this remnant vegetation is highly degraded. The acacia woodland on the west side of the pool beyond the riparian zone is contracting. There was a small shallow pool on the southern end of the wetland, with a thin salt crust, when visited.

Figure 3.7.1. Wetland #7, illustrating the loss of riparian zone on the west and east sides following prolonged inundation

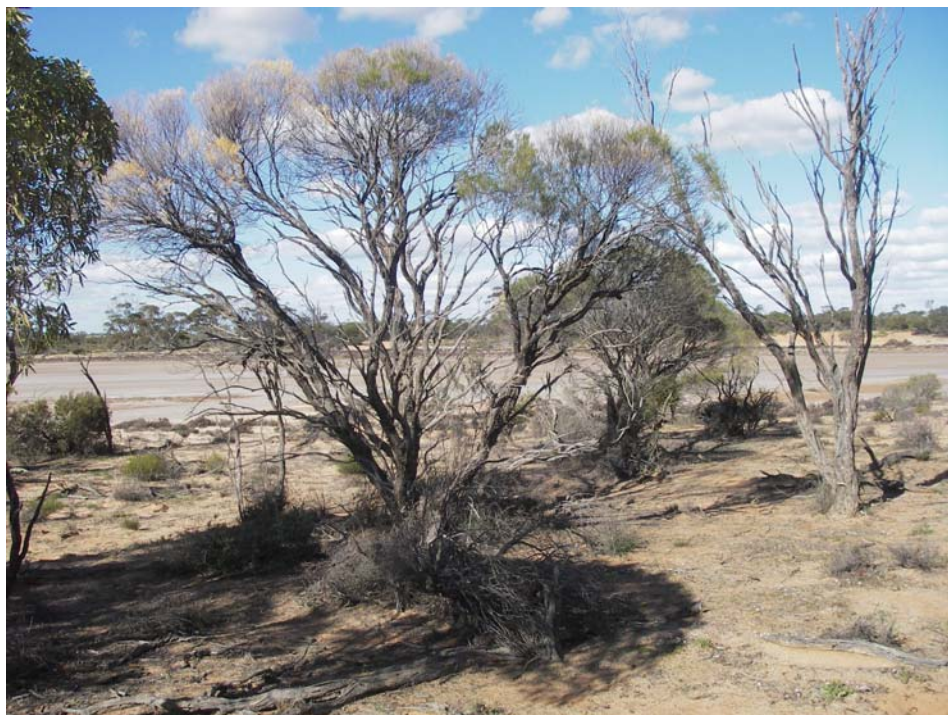
Figure 3.7.2. Wetland #7, showing sparse acacia woodland beyond the riparian zone
